## ASOS MODIFICATION NOTE 60 (for Electronics Technicians)

SUBJECT : Acquisition Control Unit (ACU) Memory Erasable Programmable Read Only Memory (EPROM) Firmware Version 2.50

Data Collection Package (DCP) Boot EPROMs Firmware Version 1.80

PURPOSE : Time Critical Firmware Upgrade for the Automated Surface Observing System (ASOS) Operational Load. **Installation must be completed on or before November 4, 1998.**

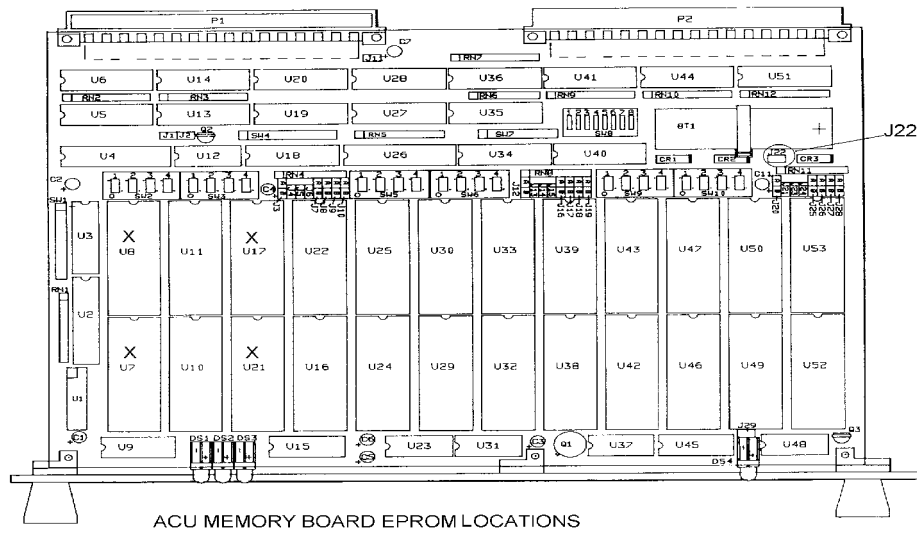
FIGURE 1

All ASOS application software is contained on the four EPROM IC on ACU memory board 1A2A3. Figure 1 illustrates the ACU memory board and identifies the four EPROMs (U7, U8, U17, and U21) to be replaced. Figure 2 illustrates DCP memory board 2A1A2A1 and/or 2A1A2A2 and identifies EPROMs (U29 and U30) to be replaced. The EPROMs are 32-pin dual in-line package CMOS devices, each providing 512K x 8 bits of storage. Upgrading ASOS software requires only replacing the four EPROMs on the ACU memory board with a higher revision level of ICs.

EPROM  
U7  
U8  
U17  
U21

10. Remove the new EPROM ICs from the protective package and insert them into the memory board sockets in accordance with the following chart. Ensure that the EPROMs are installed with pin 1 (as identified by the notch in top of IC) oriented toward board connectors P1 and P2 as shown on figure 1.

<u>IC socket</u>	<u>IC part number</u>
U7	62828-45004-1
U8	62828-45002-1
U17	62828-45003-1
U21	62828-45005-1
